# ASBESTOS, LEAD PAINT, AND PCB CAULK SURVEY REPORT

**Vacant Building  
24 Church Street  
Lyons, New York**

January 2025

Project No. 50514-08

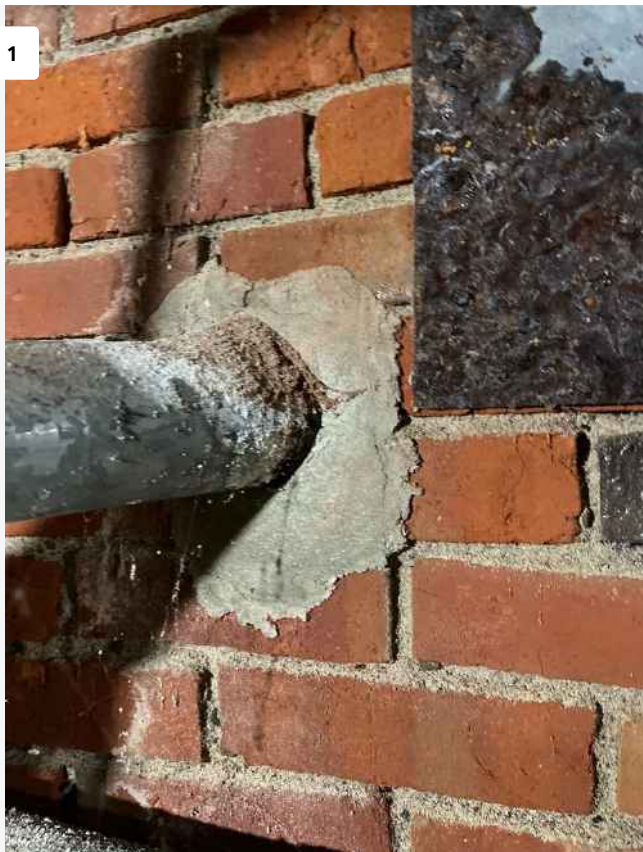
1

Asbestos Containing Refractory Cement in Basement

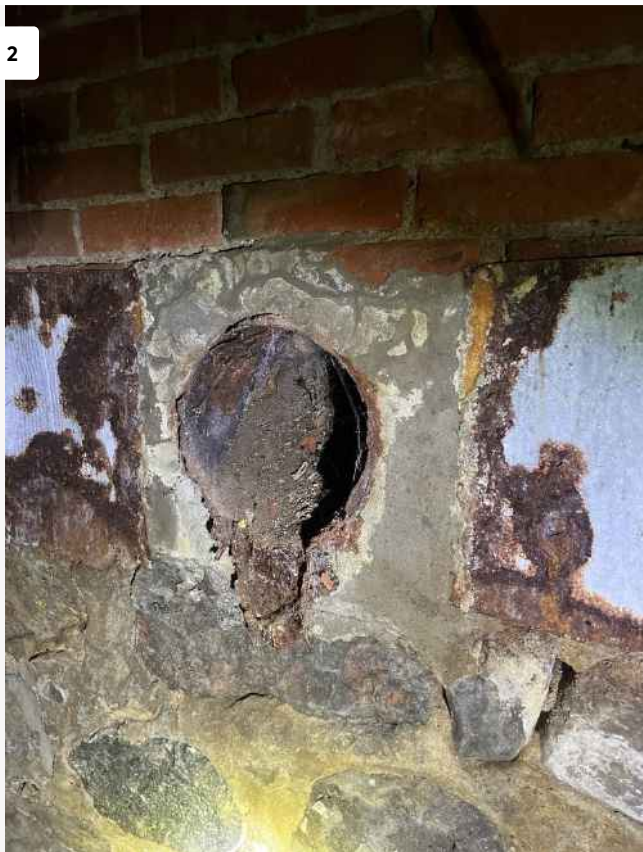
2

Asbestos Containing Refractory Cement in Basement

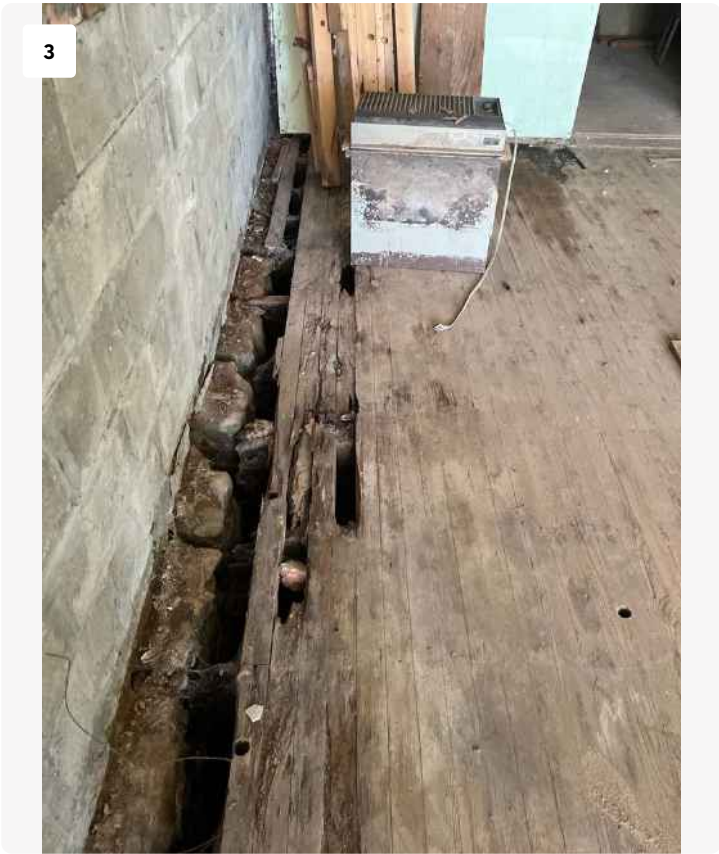
During this site visit, our inspectors visually identified additional hazards. These hazards include, but are not limited to animal waste, mold, structural deterioration, etc. Additional precautions may be necessary.

Structural Deterioration on First Floor, West Side of the Building

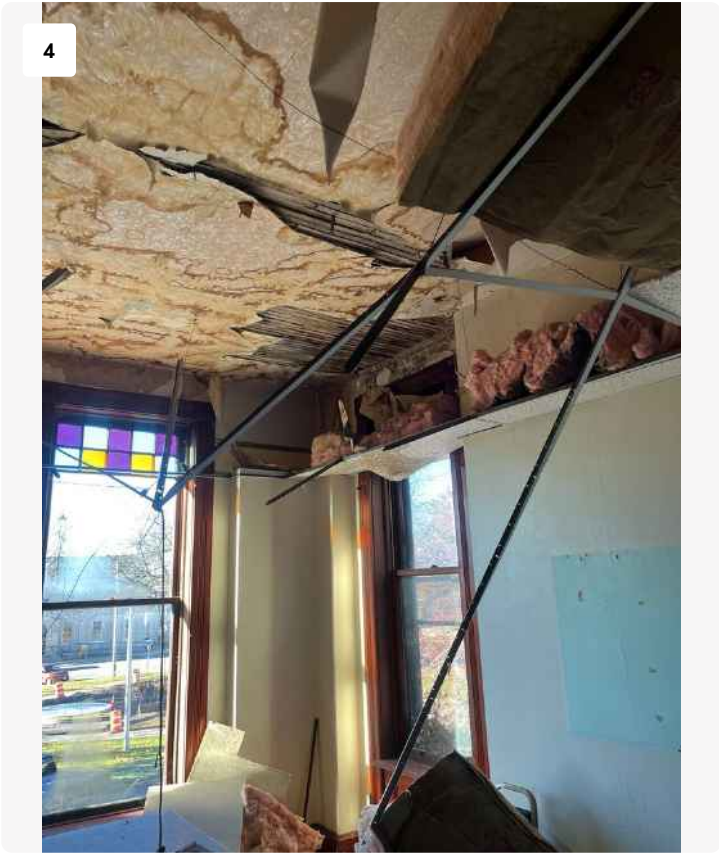
Deterioration on Second Floor

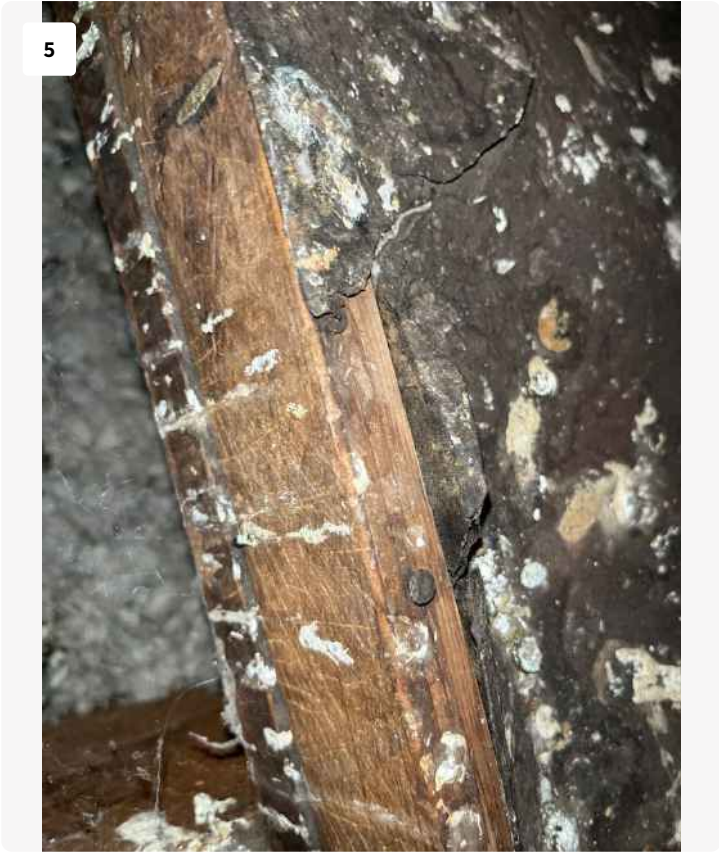
Animal (Bird) Waste at Roof Hatch

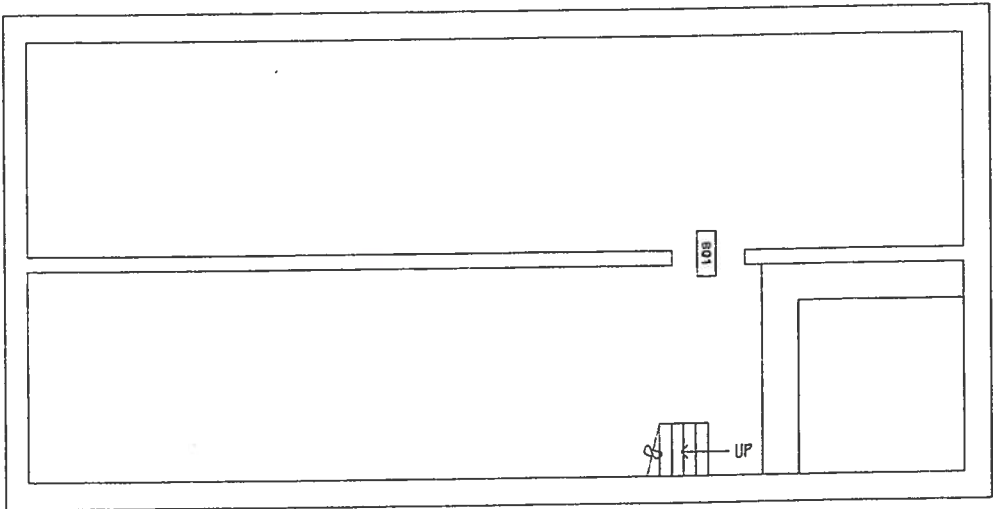
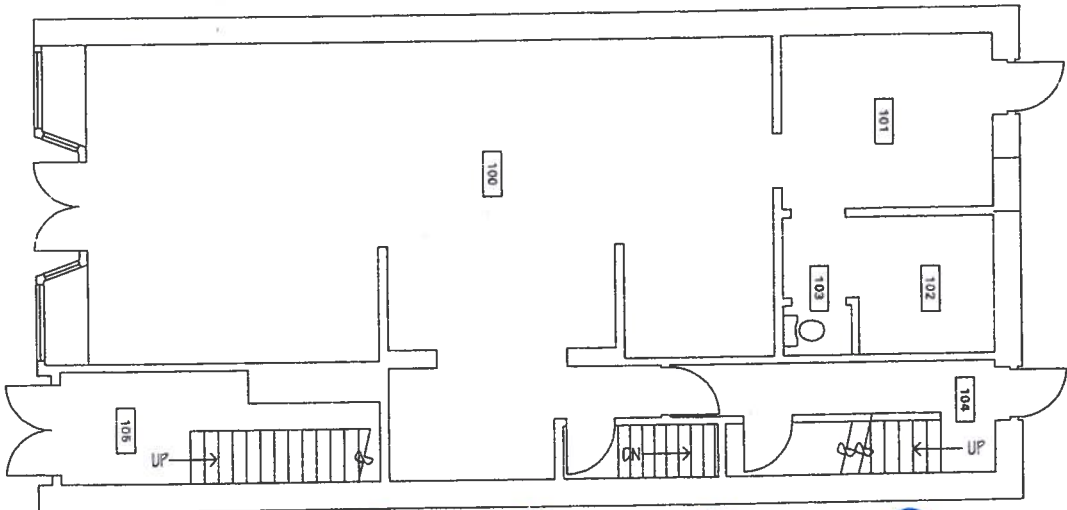
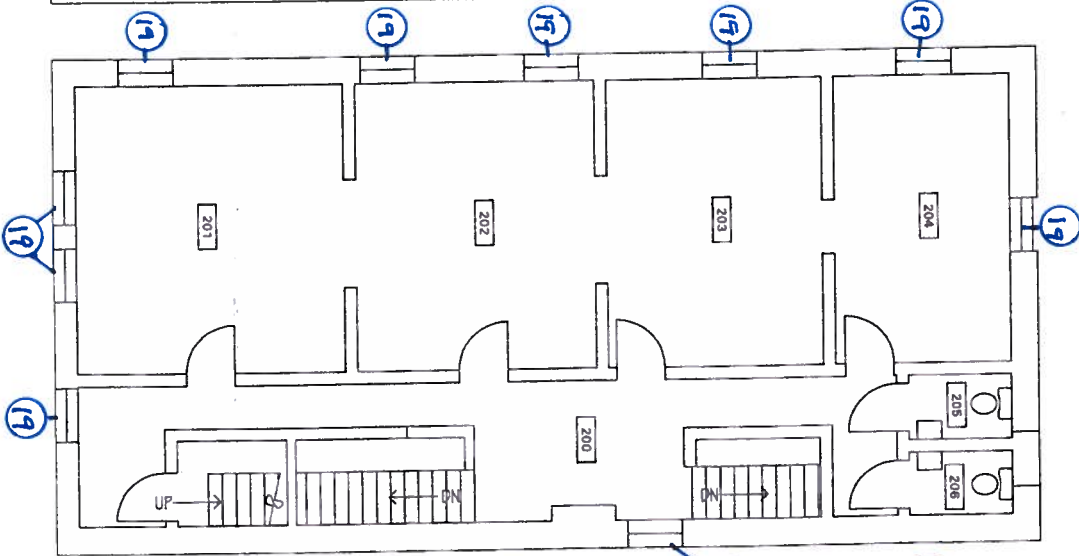
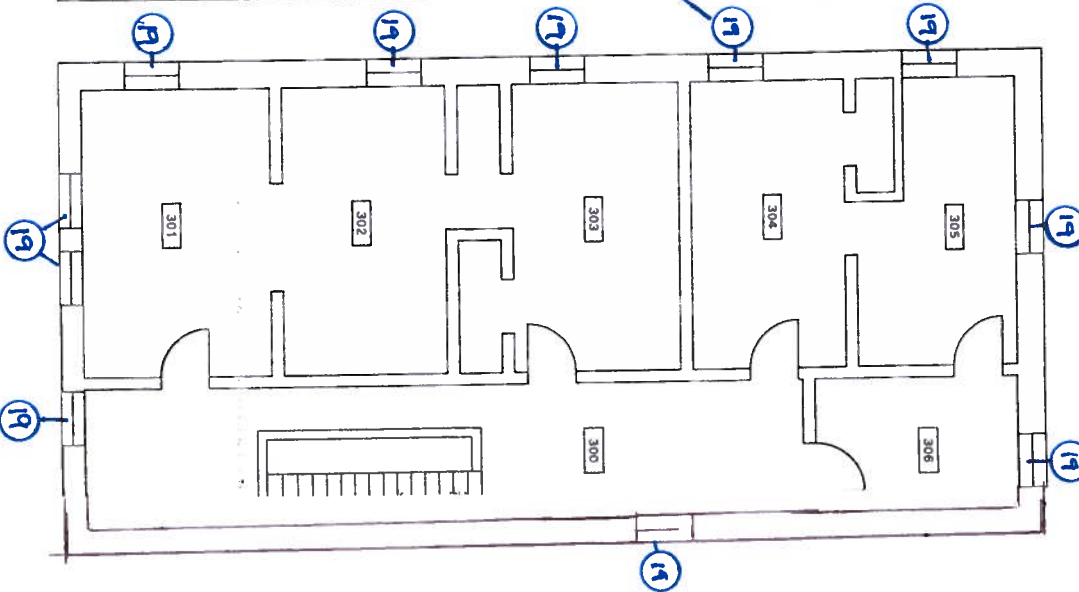
LEGEND  
○ - APPROXIMATE LOCATION  
OF ASBESTOS CONTAINING  
WINDOW GLAZING
