ASBESTOS LEAD PAINT AND PCB CAULK SURVEY REPORT

**Abandoned Building
42 Canal Street
Lyons, Wayne County, New York**

July 2022

Project No. 50514-01

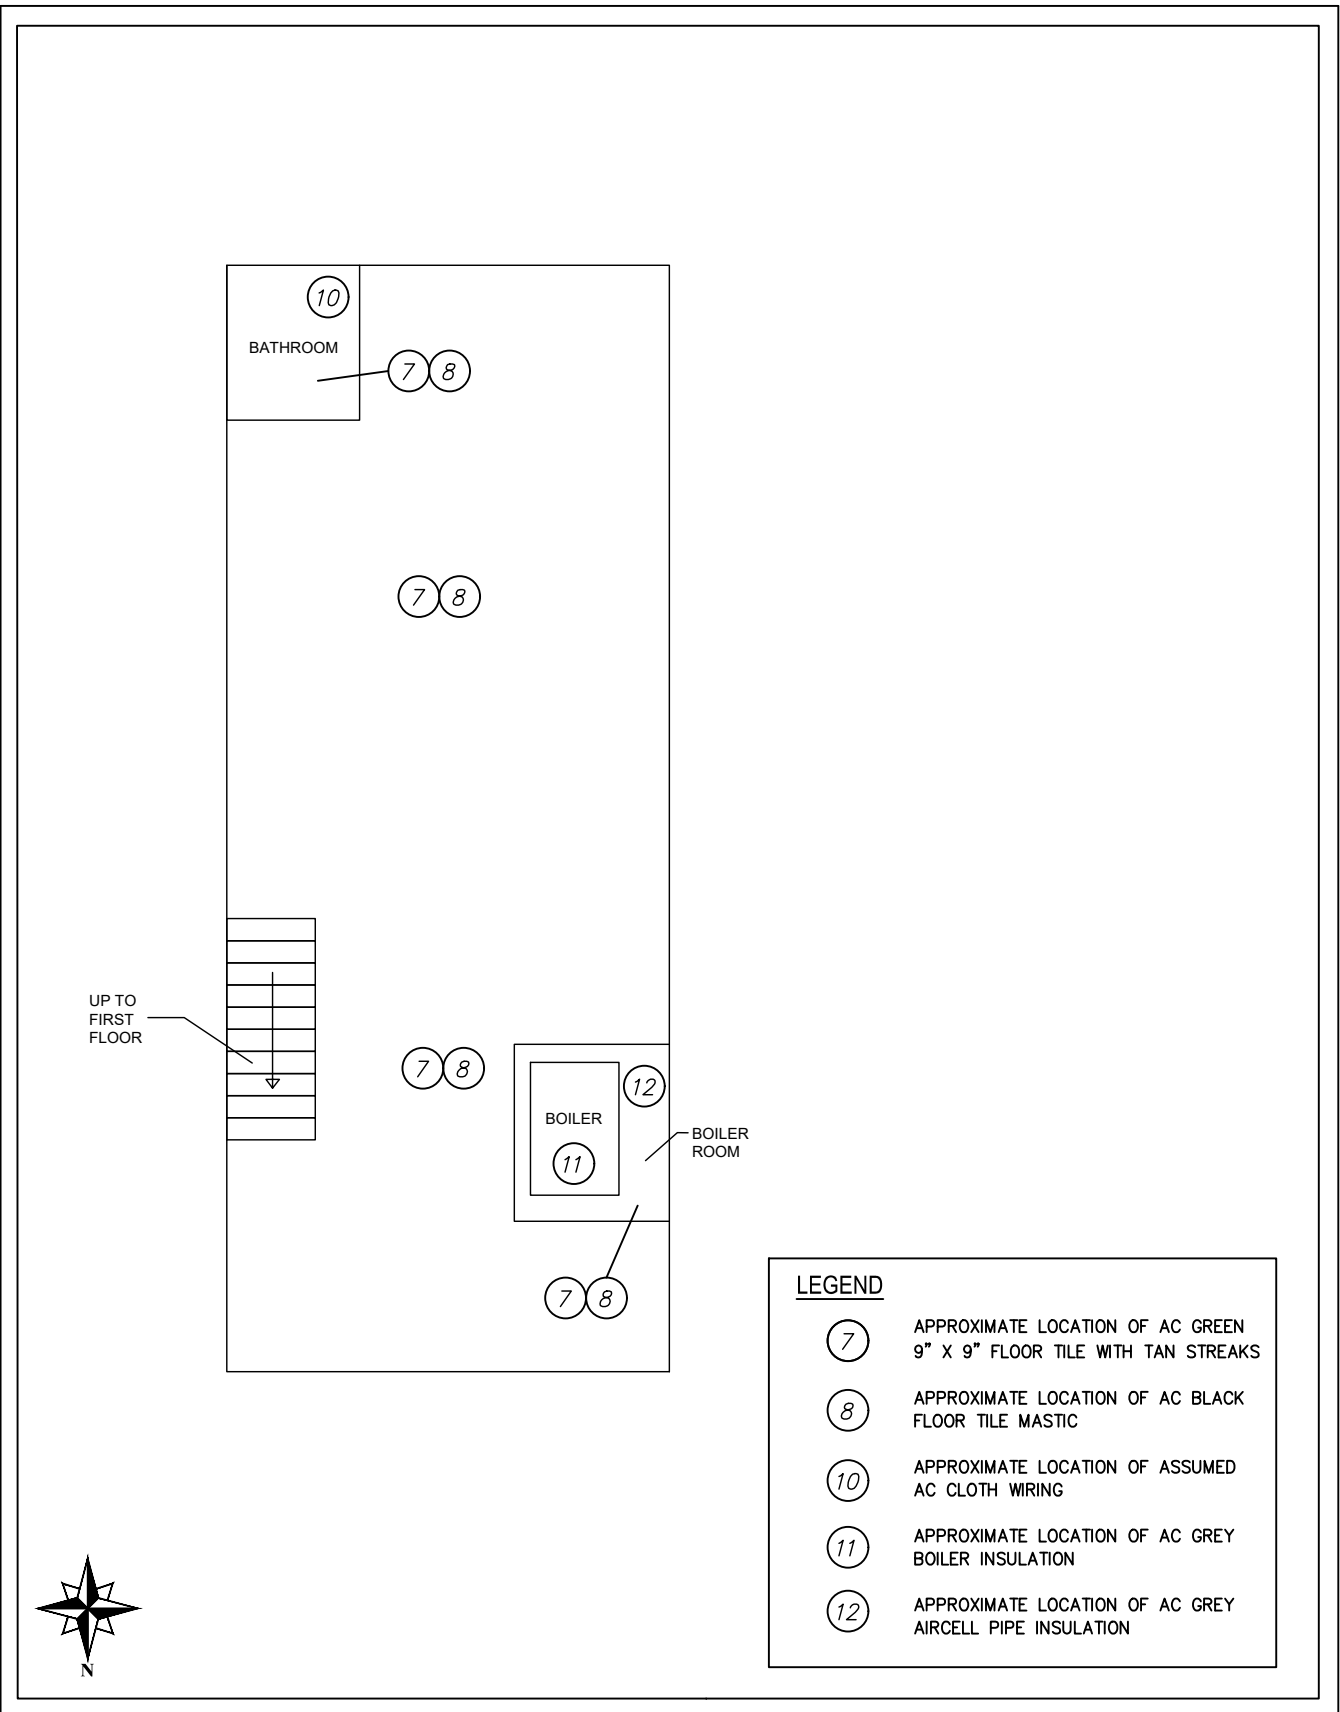
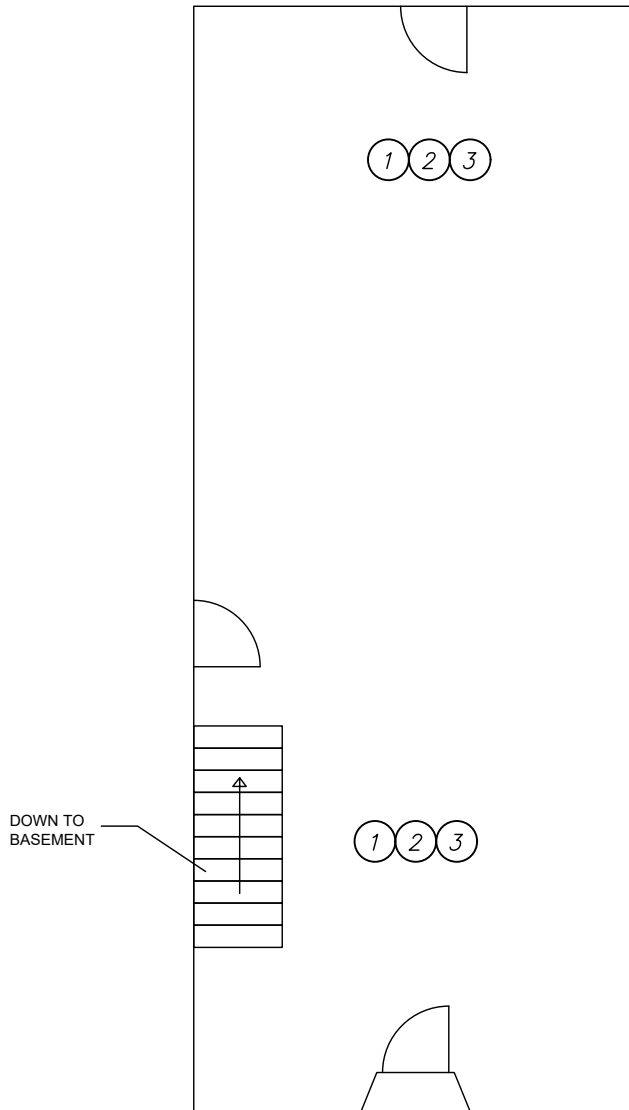
FIGURE 3. ASBESTOS LOCATION PLAN
 42 CANAL STREET
 LYONS | WAYNE COUNTY | NEW YORK
 BASEMENT PLAN

- ① APPROXIMATE LOCATION OF AC DARK RED 9" X 9" FLOOR TILE
- ② APPROXIMATE LOCATION OF AC BLACK FLOOR TILE MASTIC
- ③ APPROXIMATE LOCATION OF AC BLACK VAPOR BARRIER
