ASBESTOS, LEAD PAINT, AND PCB CAULK SURVEY REPORT

Pre-Renovation RBM Survey
Vacant Structure
52-54 Canal Street
Lyons, New York

Lu Engineers
280 East Broad Street, Suite 170
Rochester, New York 14604

February 2025

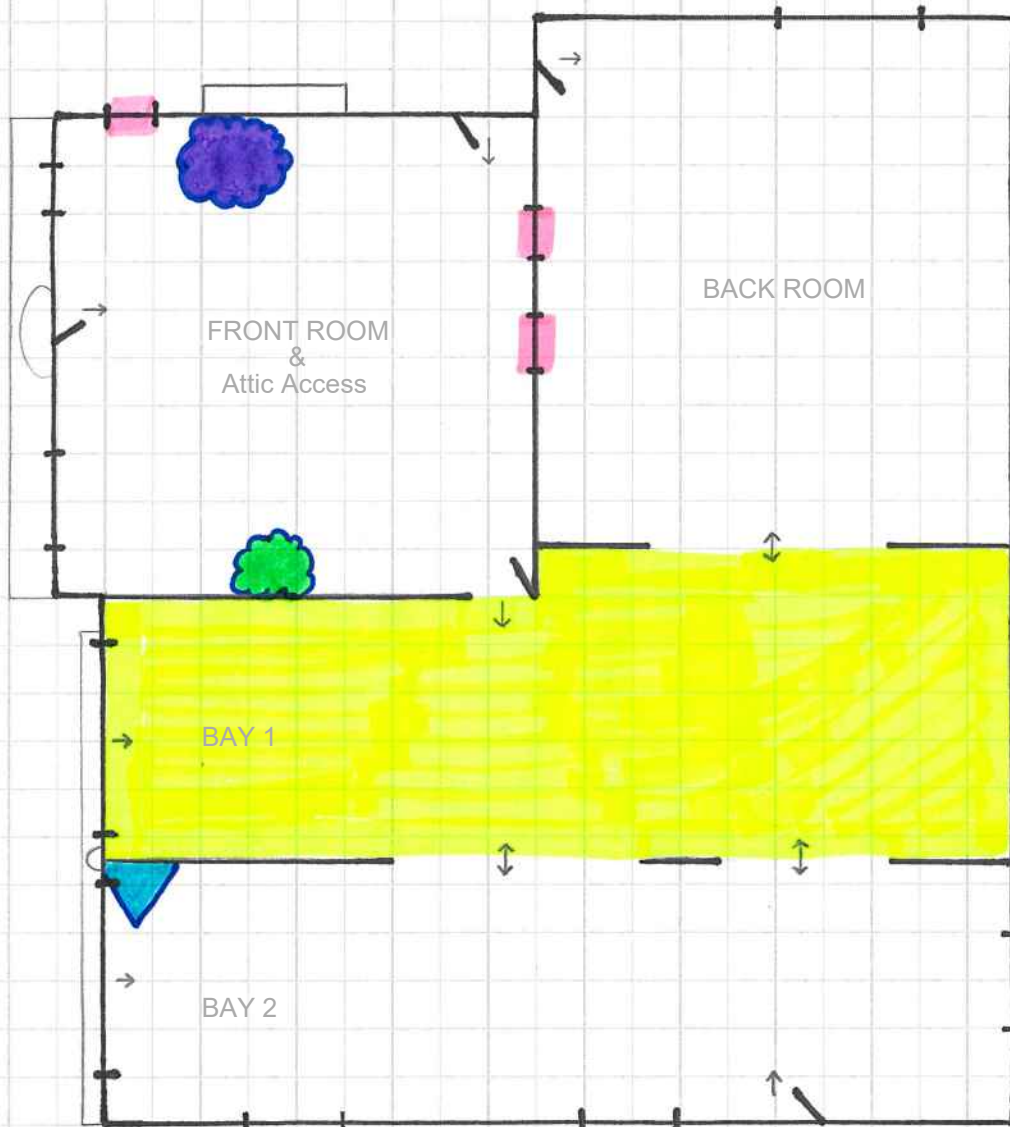
ASBESTOS LOCATION PLAN

- = Approximate location of AC White Window Glaze
- = Approximate location of AC Black Roofing Material
- = Approximate location of AC White Duct Insulation (Attic)
- = Approximate location of AC Air Cell Pipe Insulation (Attic)
- = Approximate location of AC Grey Plaster Rough Coat
