ASBESTOS, LEAD PAINT, AND PCB CAULK SURVEY REPORT

Wayne County Land Bank – Vacant Building
78 Canal Street
Lyon's, New York

March 2025

Project No. 50514-11

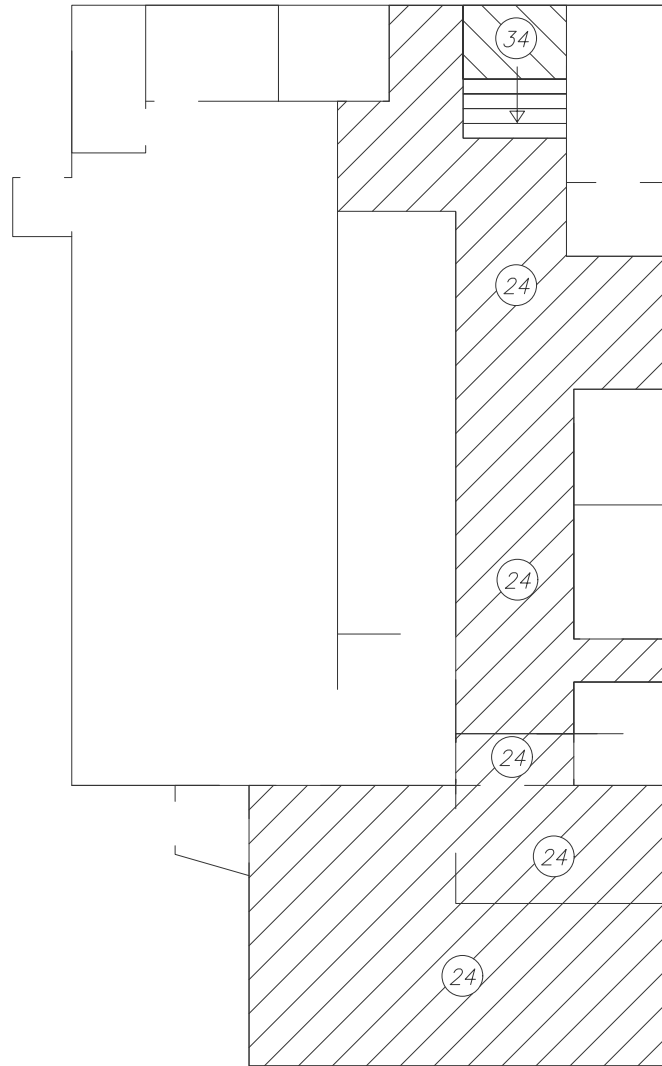
ASBESTOS LOCATION PLAN

Homogeneous Area No. (HA)	Description	Approximate Quantity
24 ^(b)	Red 12" x 12" Floor Tile	1,065 SF
24 ^(c)	Black Vapor Barrier/Mastic	1,065 SF
34	Black Mastic	35 SF

APPROXIMATE LOCATION OF
ASBESTOS CONTAINING
BLACK MASTIC

In accordance with 12 NYCRR 56, no renovation or demolition work shall be commenced by any owner or agent prior to completion of asbestos abatement performed by a licensed asbestos abatement contractor. NYSDOL regulations require that the asbestos containing material that will be disturbed by the renovation or demolition be removed prior to any disturbance of the material.
