ASBESTOS, LEAD PAINT, AND PCB CAULK SURVEY REPORT

Pre-Demolition RBM Survey
Vacant Structure
80 Canal Street
Lyons, New York

February 2025

Project No. 50514-13

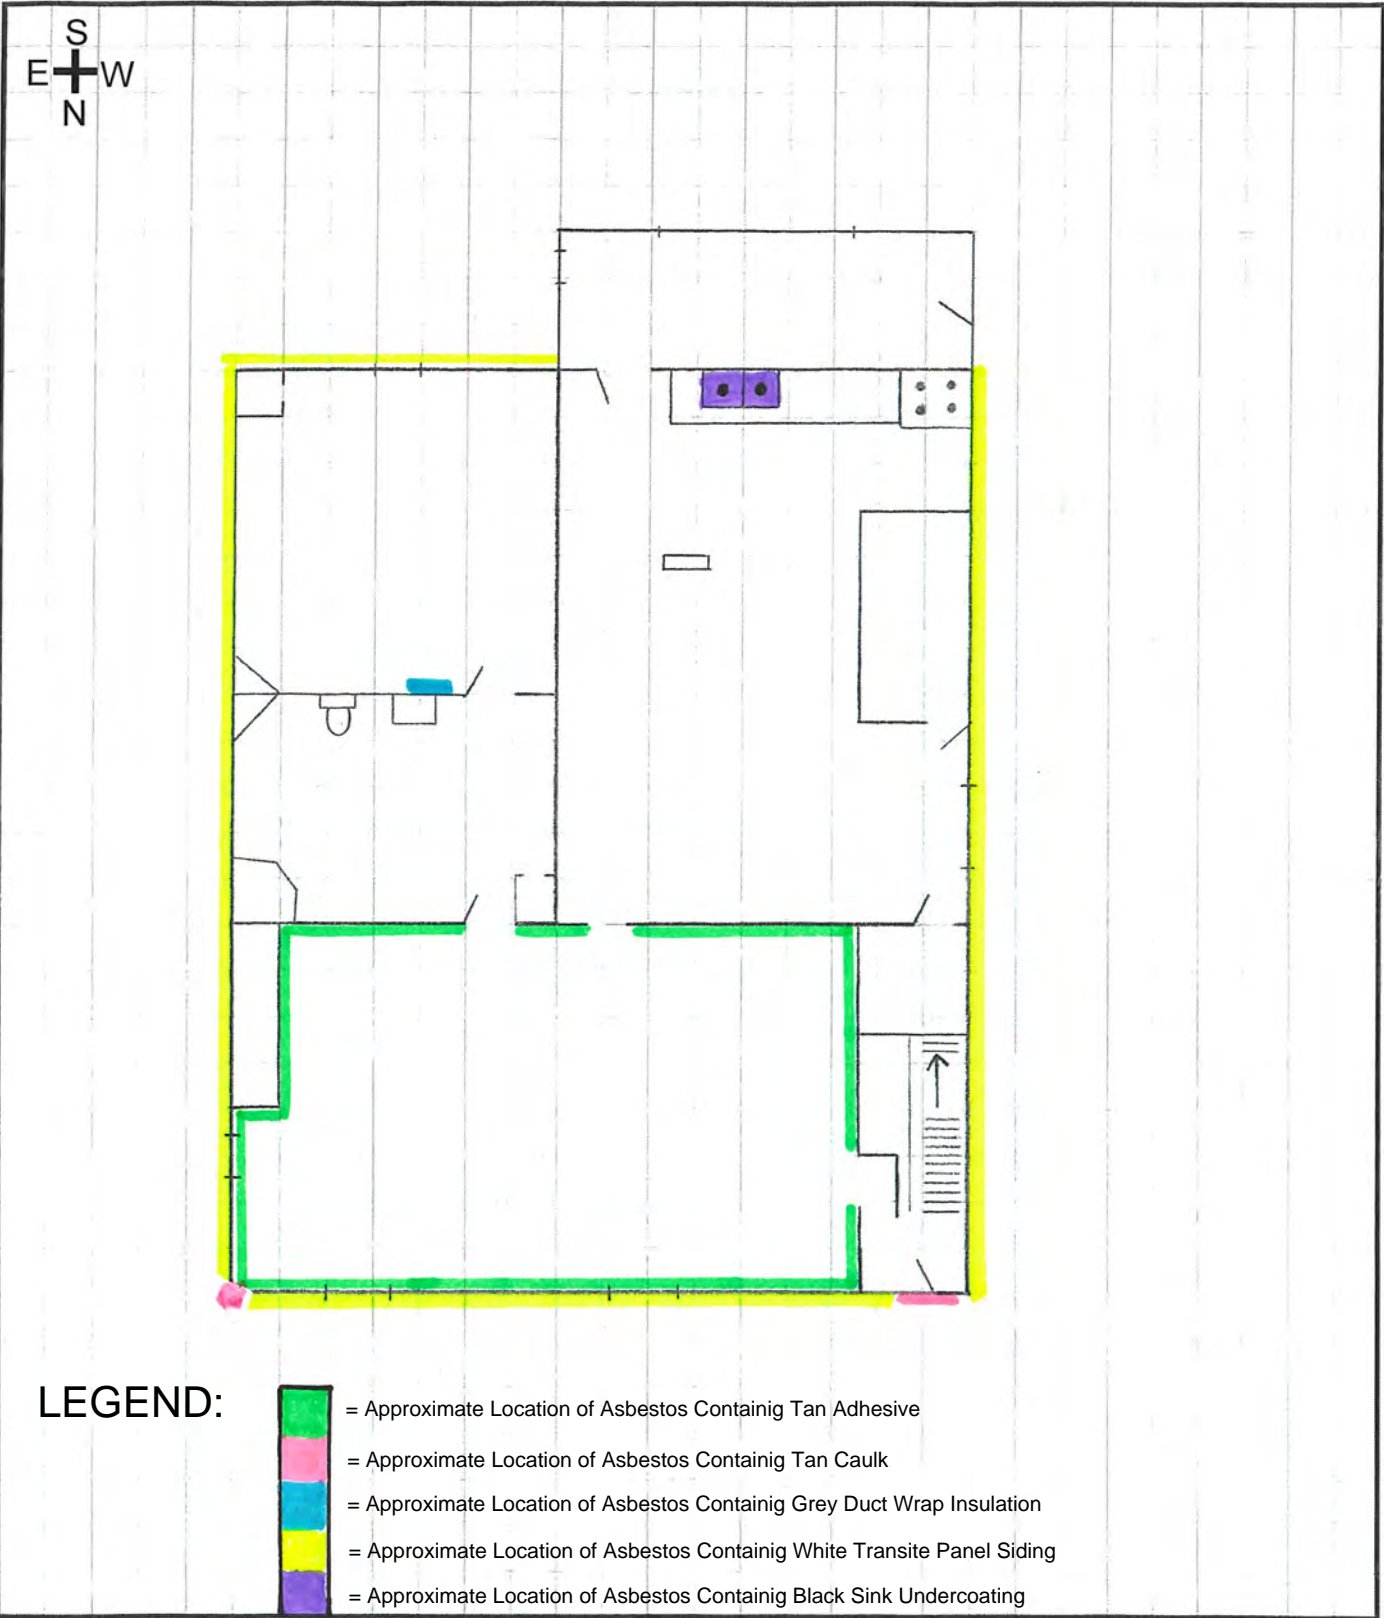
(First Floor & Exterior)

<u>Homogeneous Area Description</u>	<u>Homogeneous Area ID No.</u>	<u>Floor & Location</u>	<u>Tested or Assumed</u>	<u>ACM (Y/N)</u>	<u>Approx. Quantity</u>
Tan Adhesive	6	Living Room Wall, Behind Wood Panel	Tested	Y	419 SF
				Total	419 SF
Grey Duct Wrap Insulation	20	1 st Floor Bedroom, Behind North Wall	Tested	Y	14 SF
				Total	14 SF
Black Sink Undercoating	25	1 st and 2 nd Floor Kitchen Sinks	Tested	Y	3 SF
				Total	3 SF
Tan Caulk	34	Front Entrance Door Exterior and Northeast Corner Exter	Tested	Y	15 LF
				Total	15 LF
White Transite Panel Siding	37	North, South, East and West Exterior	Tested	Y	2,156 SF
				Total	2,156 SF
