ASBESTOS, LEAD PAINT, AND PCB CAULK SURVEY REPORT

Pre-Demolition RBM Survey
Vacant Structure
88 Canal Street
Lyons, New York

January 2025

Project No. 50514-12

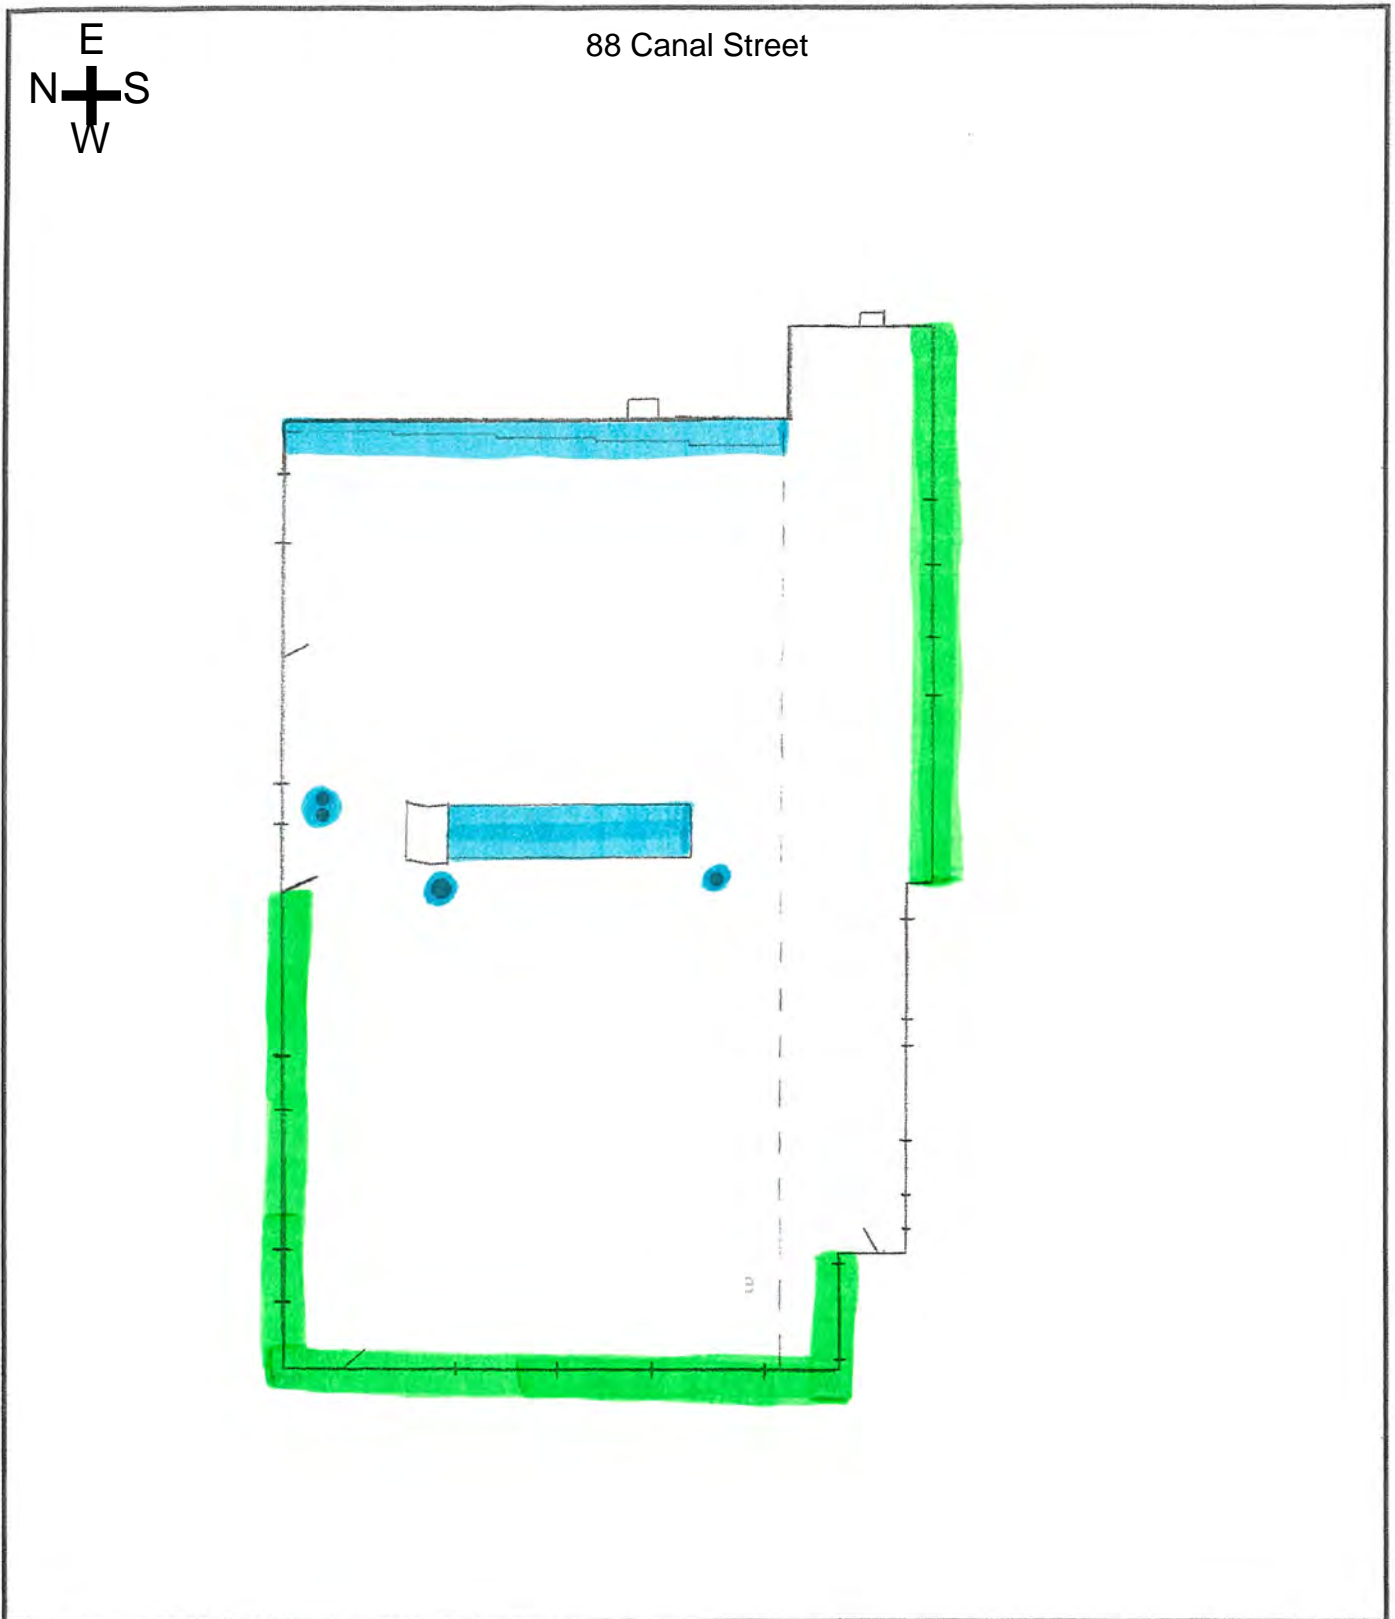
ASBESTOS LOCATION PLAN

Homogeneous Area No. (HA)	Description	Approximate Quantity
5	White Plaster Skim Coat, on North, West, and South Exterior	814 SF
18	Silver/Black Coating on North Roof (On Air Duct, East Parapet, Electrical Conduits, Vent Pipe, and Steel Support Pole)	96 SF
