FINAL REMEDIAL DECISION

CANAL STREET REDEVELOPMENT PROJECT 42, 46, 52-54, 58-66, 67-69, 78, 80, & 88 Canal Street Lyons, New York 14489

October 2025

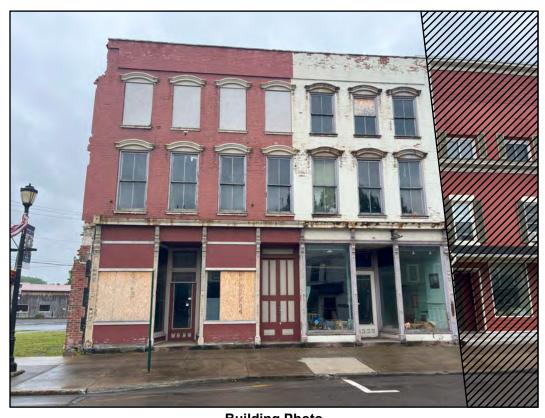
42 Canal Street (White Structure) and 46 Canal Street (Red Structure)
(Controlled Demolition with Asbestos In-Place as Per NYSDOL 56-11.5)

42 Canal St. has been condenmed and I am suggesting that it be demolished as soon as possible. This department is in support of the application of an ICR 56-11.5 – Controlled demolition approach to demolish the noted building with the asbestos containing material in place so as not to place workman in a dangerous situation.

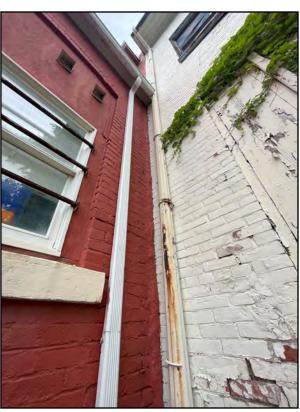
Connection Between 36-40 Canal Street (Red Brick) to Remain and 42 Canal Street (White Brick) to be Demolished

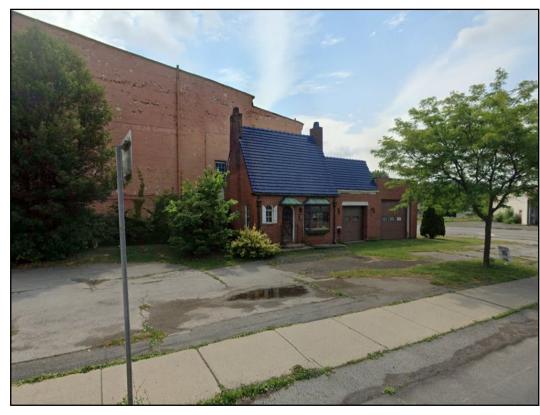
Building Photo
52-54 Canal Street; 58-66 Canal Street (Pictured in Background)
(Abate ACM for Future Renovation by Others)

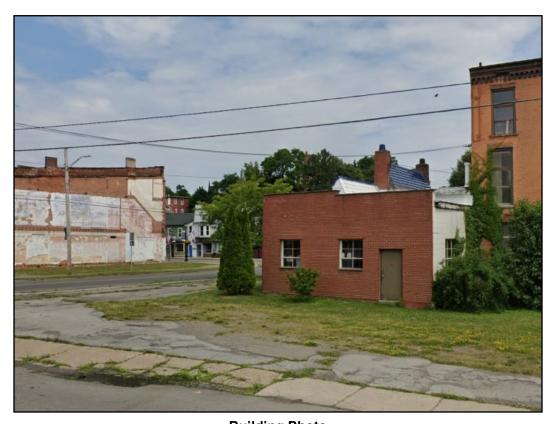
Building Photo
52-54 Canal Street; 58-66 Canal Street (Pictured Right)
(Abate ACM for Future Renovation by Others)

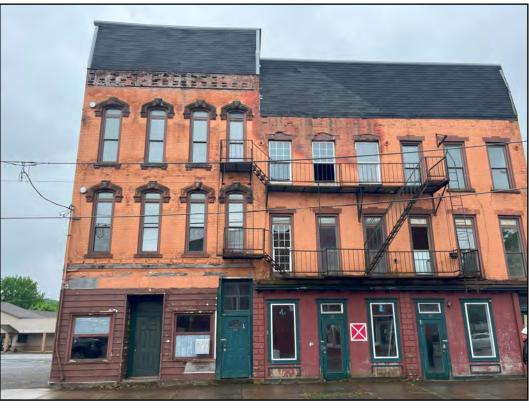
Building Photo
58-66 Canal Street
(Controlled Demolition with Asbestos In-Place as Per NYSDOL 56-11.5)

58-66 Canal St. has been condemned and I am suggesting that it be demolished as soon as possible. This department is in support of the application of an ICR 56-11.5 – Controlled demolition approach to demolish the noted building with the asbestos containing material in place so as not to place workman in a dangerous situation.

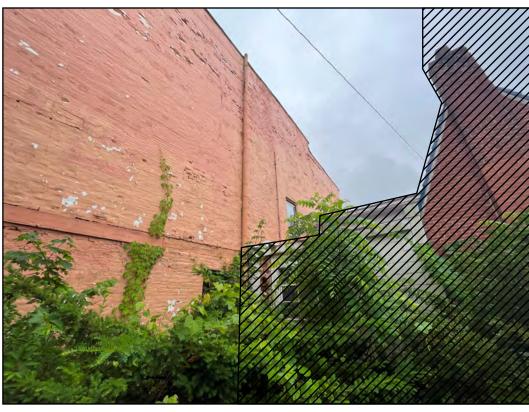
Connection Between 52-54 Canal Street (Pictured Right) to Remain and 58-66 Canal Street (Pictured Left) to be Demolished

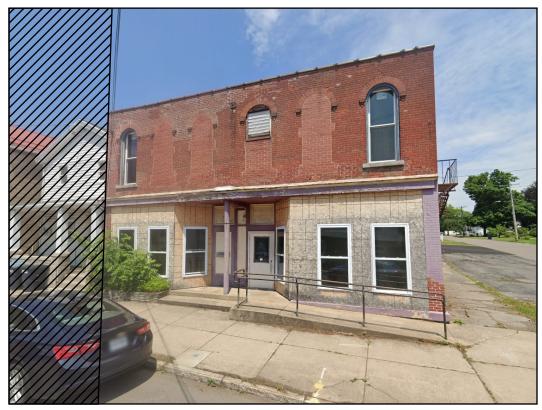
Building Photo 67-69 Canal Street (Controlled Demolition with Asbestos In-Place as Per NYSDOL 56-11.5)

67-69 Canal St. has been condemned and I am suggesting that it be demolished as soon as possible. This department is in support of the application of an ICR 56-11.5 – Controlled demolition approach to demolish the noted building with the asbestos containing material in place so as not to place workman in a dangerous situation.

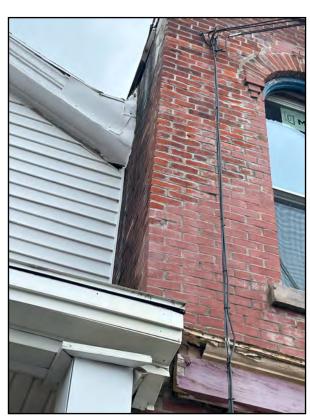
Connection Between 65 Canal Street (Pictured Left) to Remain and 67-69 Canal Street (Pictured Right) to be Demolished

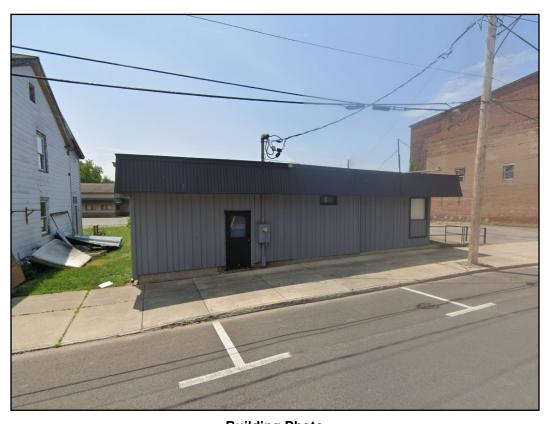
Building Photo
78 Canal Street (Center); 58-66 Canal Street (Pictured Right) and 80 Canal Street (Pictured Left)
(Abate ACM and Demolish)

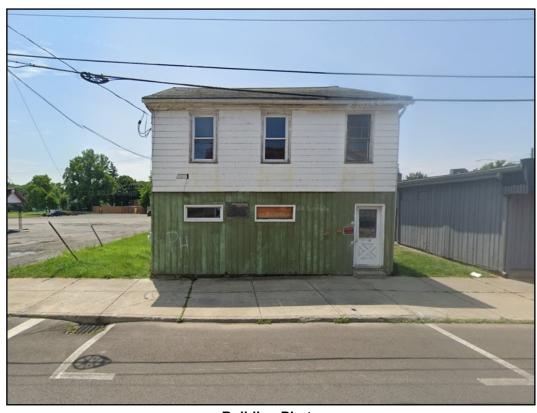
Building Photo
80 Canal Street (Center); 78Canal Street (Pictured Right)
(Controlled Demolition with Asbestos In-Place as Per NYSDOL 56-11.5)

80 Canal St. has been condemned and I am suggesting that it be demolished as soon as possible. This department is in support of the application of an ICR 56-11.5 – Controlled demolition approach to demolish the noted building with the asbestos containing material in place so as not to place workman in a dangerous situation.

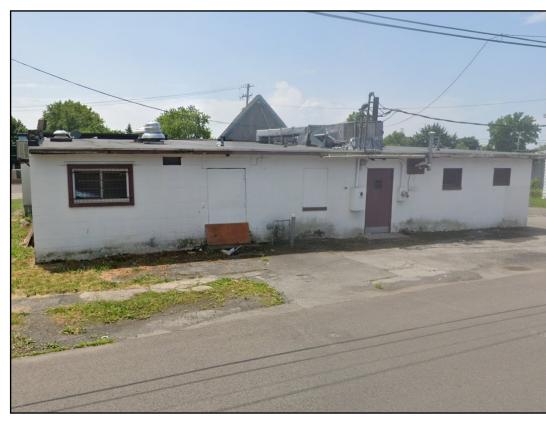
Building Photo 88 Canal Street (Abate ACM and Demolish)

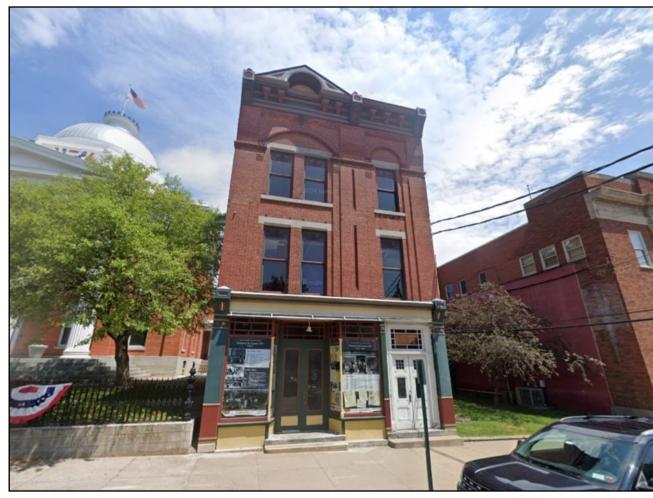
Building Photo 24 Church Street (Abate ACM for Future Renovation)
